Crash of Japan Airlines B-747 at Mt. Osutaka

Dec. 8th, 1985, near the ridge of Mt. Osutaka, Ueno, Gunma Prefecture

(Summary)

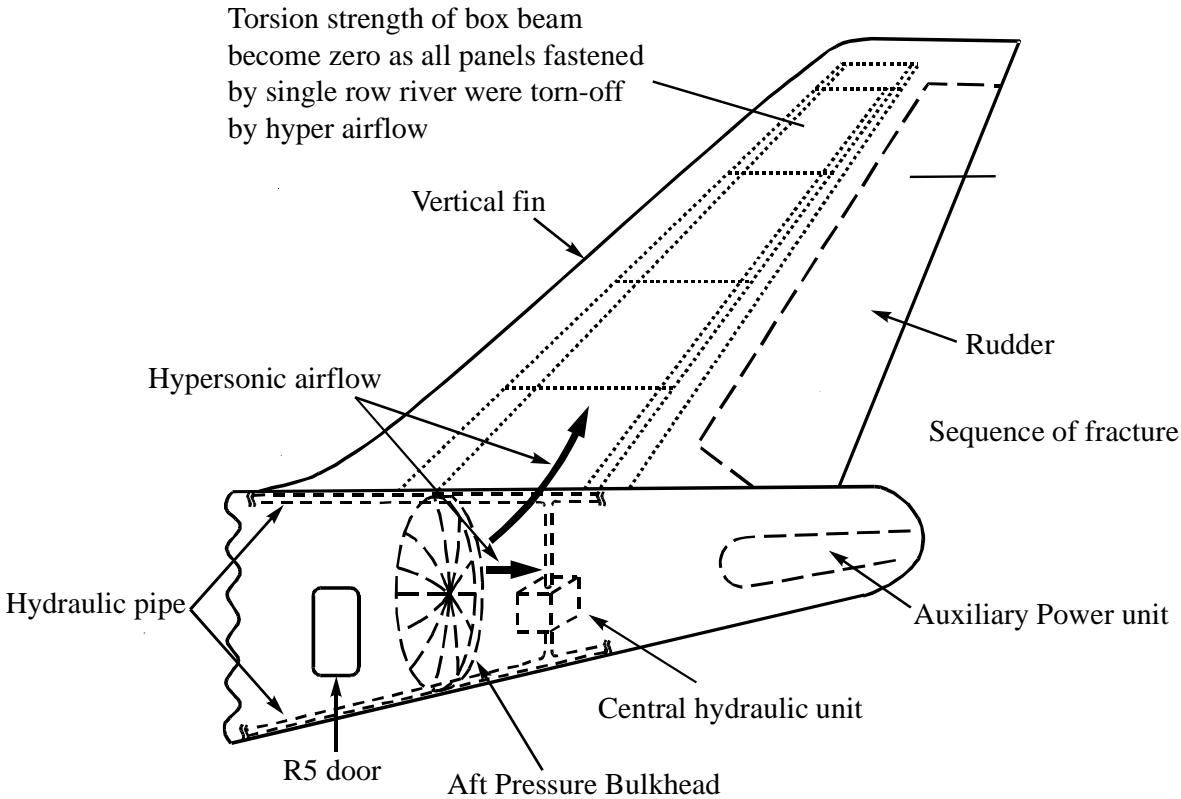
Fig. 1 Structure near the Empennage.

The direct cause of the accident was the fatigue failure of the aft bulkhead as shown in Fig. 1. The central hydraulic controlling system and APU located at the back of bulkhead as well as the box-beam structure of the vertical fin were blown off by the large mass of air moving a hypersonic velocity that was induced by this breakage.

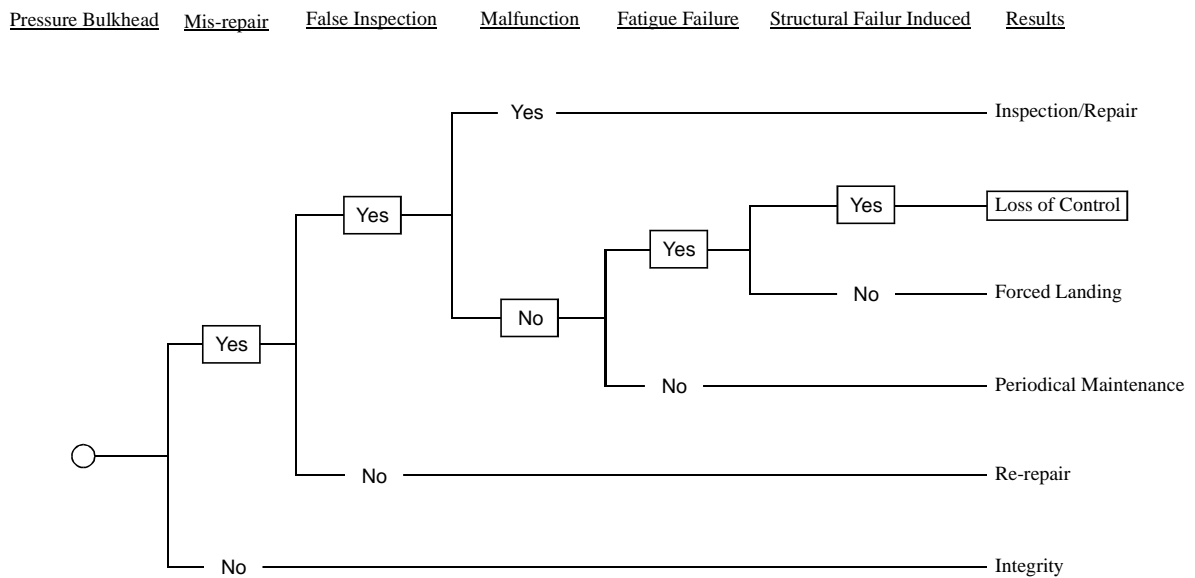
Fig. 2 Event Tree Analysis of JAL Accident Caused by Miss-repair of AFT Pressure.

The aircraft had received large-scale repairs at the maintenance field at Haneda in June 1978, after it experienced a tail hit landing at Osaka International Airport. Fatigue failure of the aft bulkhead was due to a mistake during the repairs at that time. Figures 1~3 show the details of the riveted joint that was incorrectly repaired by the engineering staff from Boeing. The repair was not conducted in accordance to the company procedure. The repair was made using two separate splice plates instead of single plate. As a result, the entire load was transmitted through the center rivet row only, and multiple site fatigue cracks initiated from the rivet holes of the center row soon after the repair. These cracks propagated by the cyclic pressurization of the aircraft and finally caused the unstable fracture of the whole structure after a total of 12,319 cycles. The repair mistake extended across two bays, which is about one-meter in length. As this was longer than the critical length necessary for the unstable failure of the structure, the crack propagated by the interlinking of adjacent small cracks without being arrested.

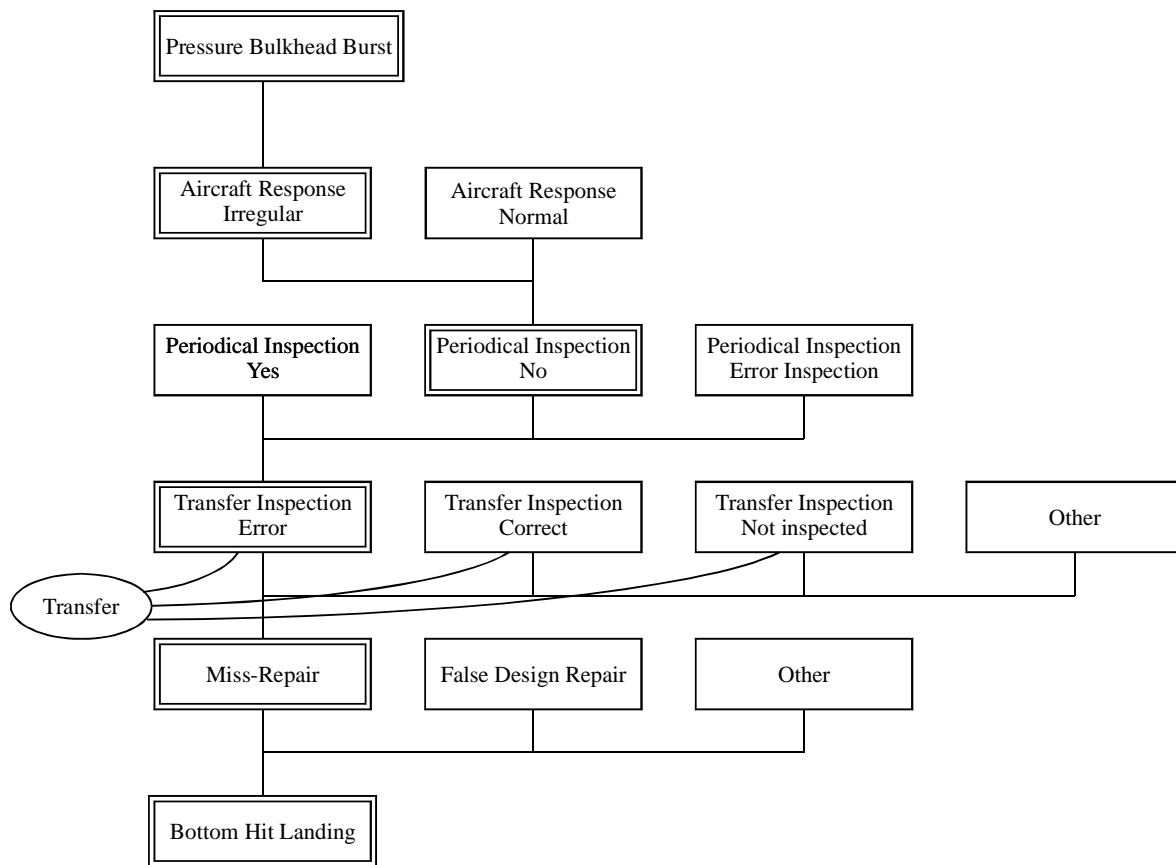
Fig. 3 Fault Tree Analysis of JAL Accident Caused by Miss-repair of Aft Pressure.

As is shown in Fig. 3, as a result of the mistake in the repair, the entire membrane stress induced by internal pressure was transmitted through just the center row fastener. Therefore, it can be judged that the fundamental mechanism of load transmission was not understood at all by the maintenance engineers.

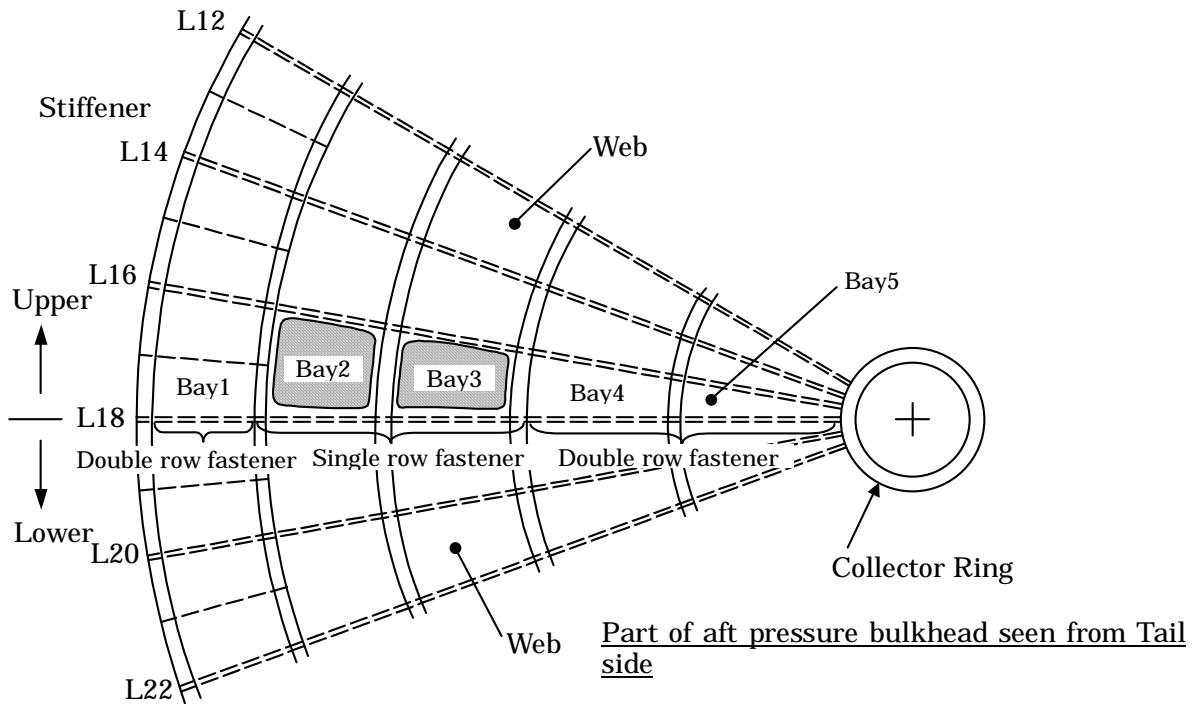
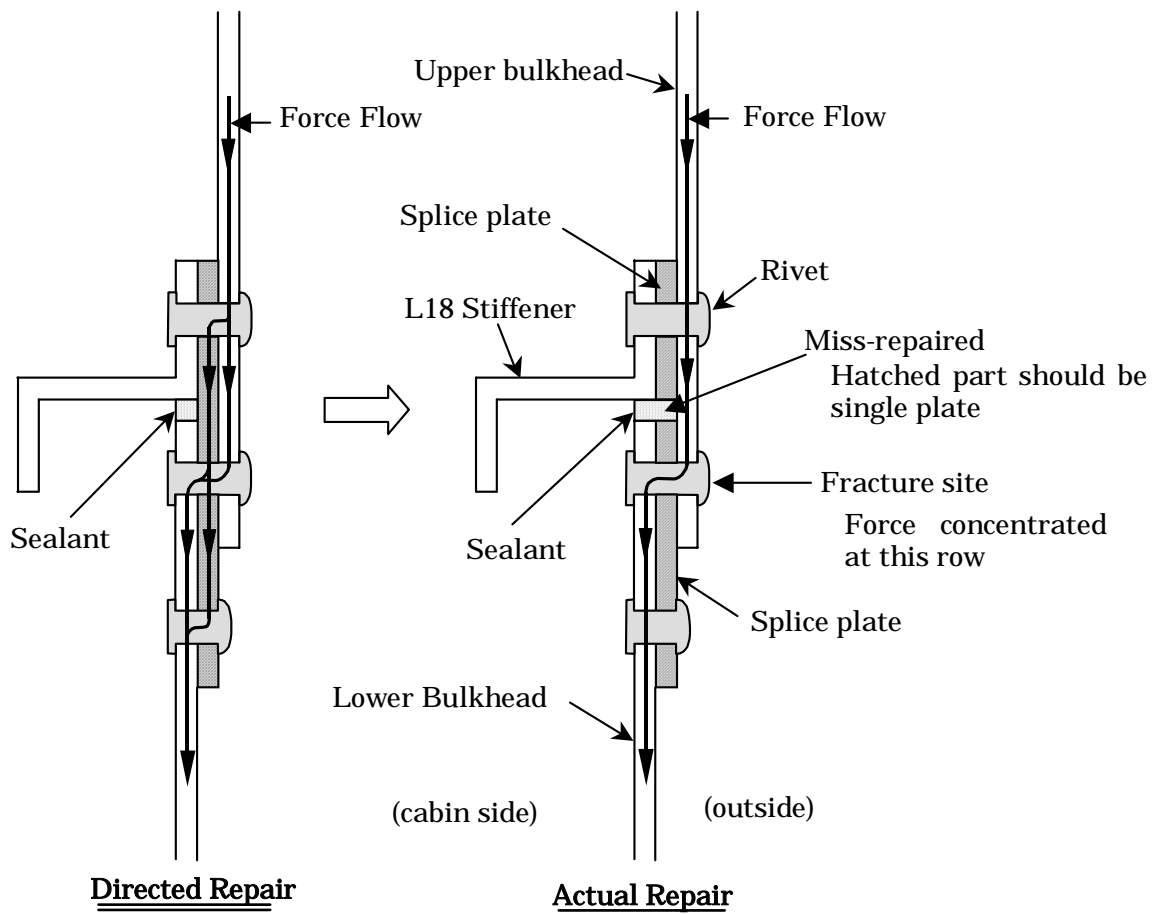
Fig. 4 The Aspect of Aft Bulkhead Repair.

One reason why multiple-site cracks occurred is that the old rivet holes were used again at the repair without resizing the holes. The JAL accident showed the potential danger of multiple-site cracks.
